PHOTOGRAPHIC SURVEY OF THE LDEF MISSION

NASA Special Publication 531

Robert L. O'Neal

National Aeronautics and
Space Administration

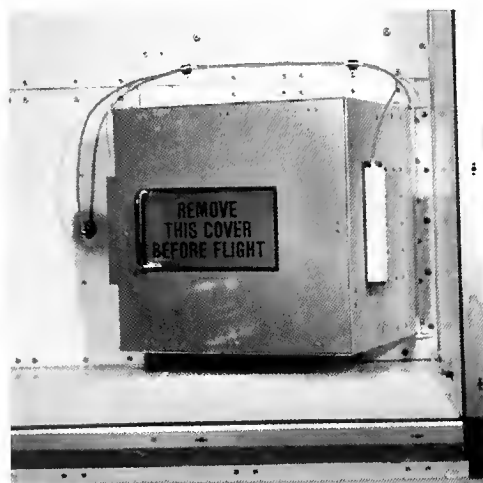
Figure 469 (Postflight). This photograph is of the lower right one-sixth of the tray. Note the brown discoloration around the grid voltage plug to the left of the canister. The cover was installed on the canister housing to protect the space-exposed hardware.

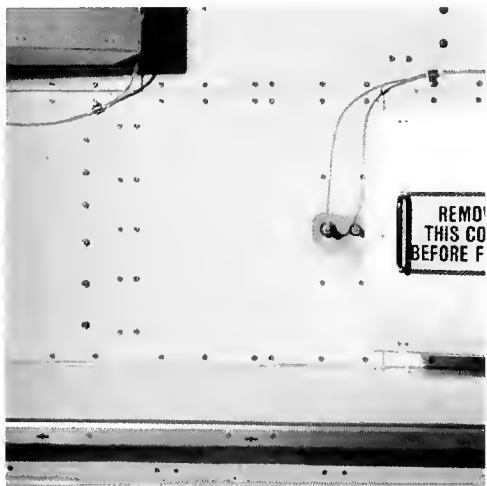
Figure 470 (Postflight). This photograph is of the lower center one-sixth of the tray. Note the brown discoloration around the grid voltage plug to the left of the canister. The cover was installed on the canister housing to protect the space-exposed hardware.

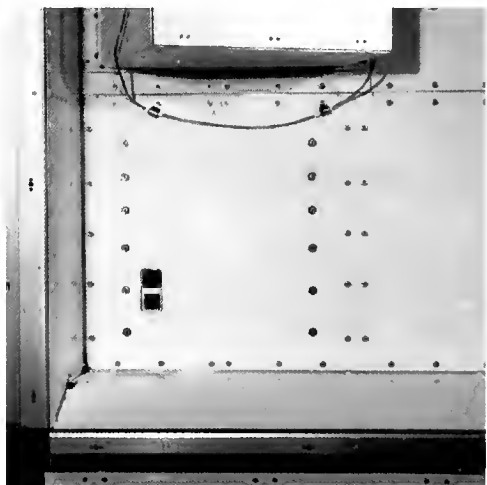
Figure 471 (Postflight). This photograph is of the lower left one-sixth of the tray. There is little, if any, discoloration present.

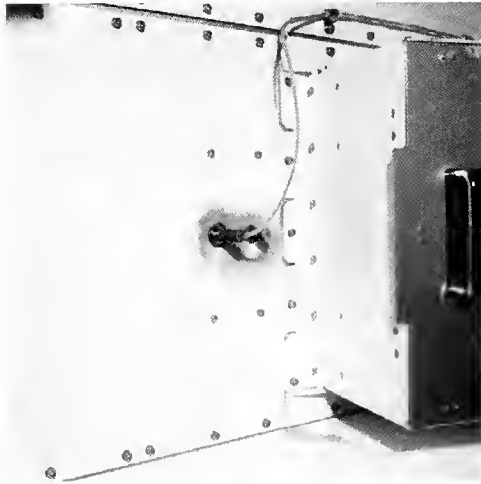
Figure 472 (Postflight). This close-up photograph is of the lower right corner canister. Note the discoloration around the grid voltage plug and the well-defined discoloration pattern on the tray wall.

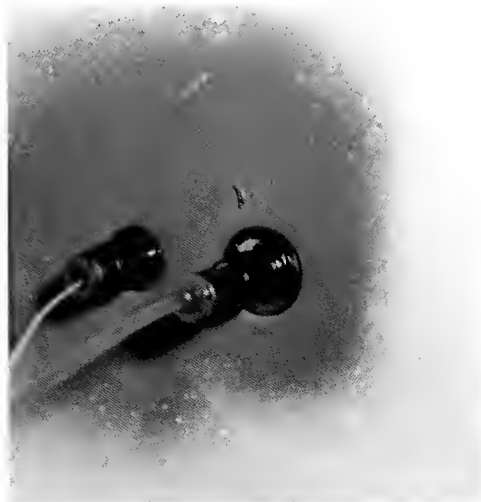
Figure 473 (Postflight). This close-up photograph is of the grid voltage plug that was located to the right of the upper left canister. Note the dark discoloration and the small piece of debris from one of the other experiments.

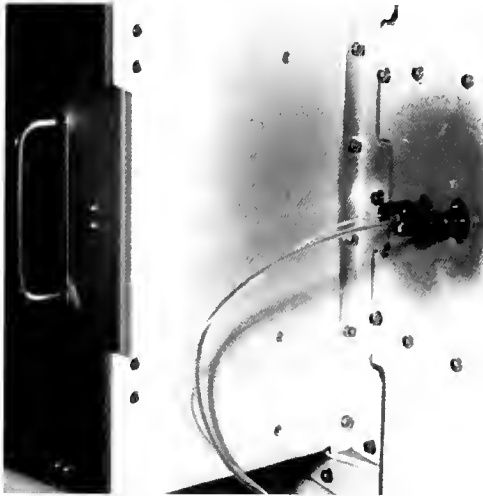
Figure 474 (Postflight). This close-up photograph is of the grid voltage plug that was located to the right of the upper left canister. Note the discolored area around the plug and the discoloration pattern on the canister wall.

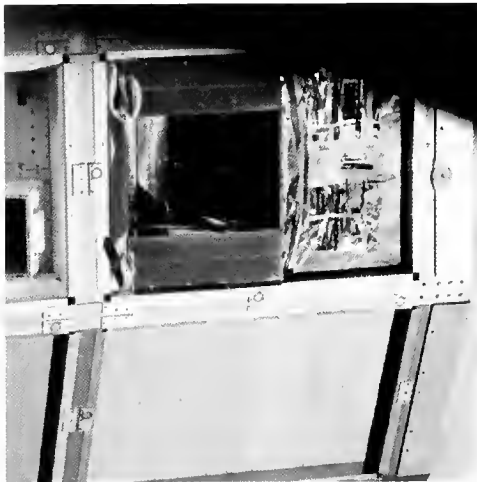
Figure 475 (In Flight). A portion of the greenish-gray tint on the two debris panels is a by-product of the chromic anodize coating process; however, a large part can be attributed to reflections of the blue sky. The vertical streaks in the panels are by-products of chromic anodizing that have been enhanced significantly by the blue reflection. Two darker blue horizontal discolorations are visible near the vertical center of each panel.

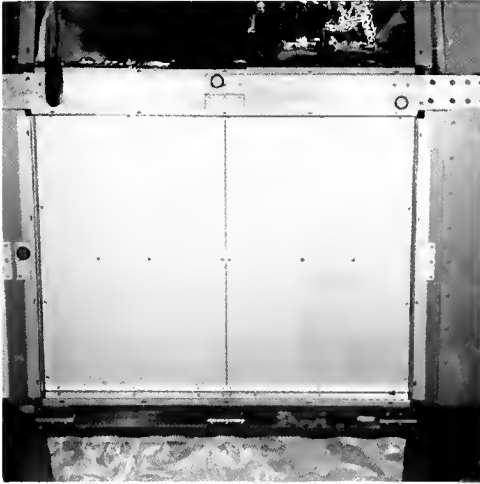
Figure 476 (Postflight). The pink and greenish-gray tints on the two debris panels are by-products of the chromic anodize coating process and are not attributed to contamination or exposure to the space environment. The vertical streaks that were on the panels in the in-flight photograph are still visible, but they are much lighter because the reflection of the sky is not present. The same can be said for the two discolorations; they are still visible, but are much lighter. The light band along the sides and across the bottom of the panels is caused by light reflecting from the tray sidewalls.

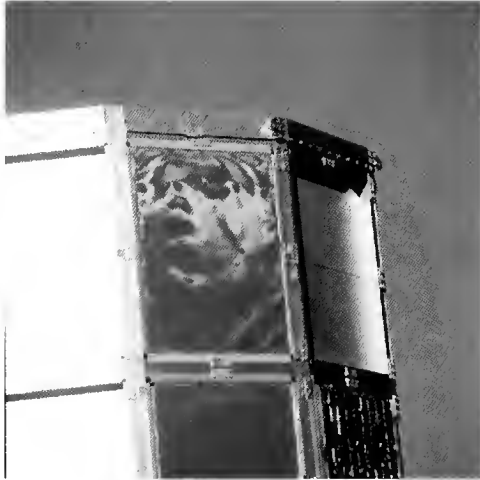
Figure 479 (In Flight). The silvered Teflon thermal cover appears to be without physical damage. The three dark spots appearing in a vertical row about a third of a tray width from the right edge of the cover are three Velcro attachment pads. The lighter areas appear diffuse in other photographs.

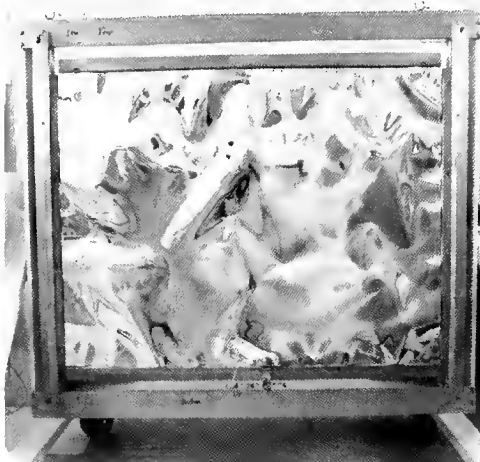
Figure 480 (Postflight). The silvered Teflon thermal cover is without physical damage. The surroundings are reflected in the surface of the thermal cover. In general, the thermal cover appears specular except for an area in the lower center of the tray, which appears to be somewhat dull. A similar condition was noted on the thermal cover of tray A2 at the other end of the LDEF.

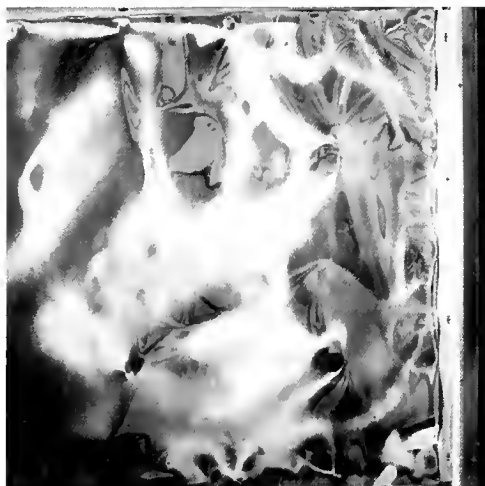
Figure 481 (Postflight). This close-up photograph is of the diffuse area of the thermal cover. Surrounding areas are specular and reflect nearby surroundings.

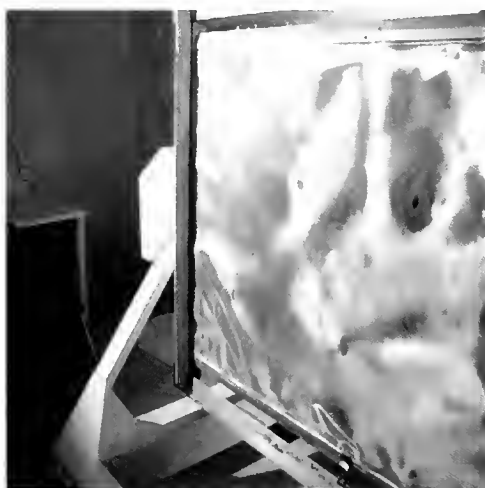
Figure 482 (Postflight). This oblique view of the thermal cover shows the diffuse area of the thermal cover.

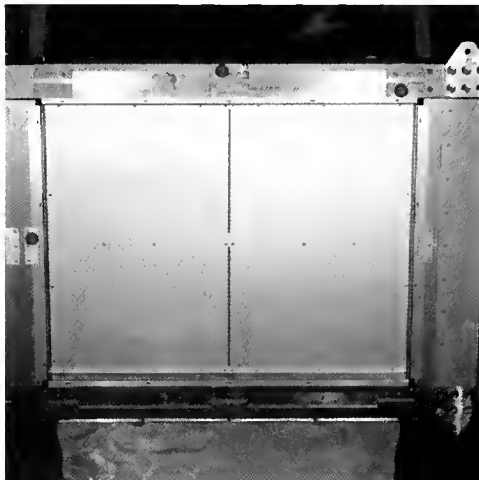
Figure 483 (Postflight). The pink and greenish-gray tints on the two debris panels are by-products of the chromic anodize coating process and are not attributed to contamination or exposure to the space environment. The light band along the sides and across the bottom of the panels is caused by light reflecting from the tray sidewalls.

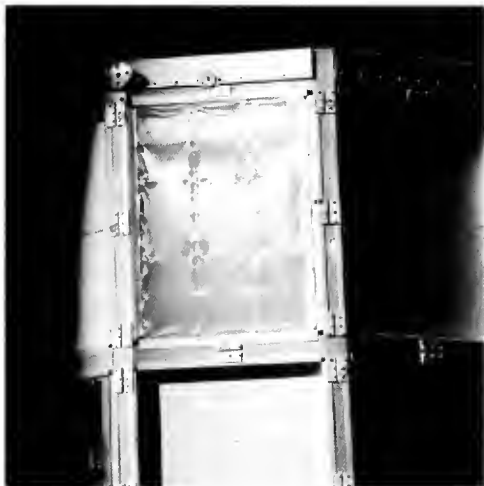
Figure 484 (In Flight). The thermal cover appears to be specular and intact with several small circular areas that appear to be impacts. The cover is more taut than in the prelaunch photograph. The wrinkled spots on the thermal cover are areas where Velcro attachment pads are bonded to the back of the cover. The scalloped effect around the cover edges occurs between the attachment pads. The ground strap is in place and has no visible damage.

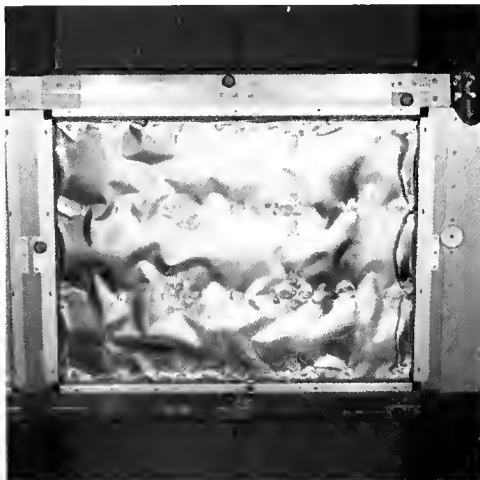
Figure 485 (Postflight). The thermal cover appears to be specular and intact. Because of lighting, the locations that appeared to be impacts in the in-flight photograph are not apparent. The thermal cover is less taut than in the in-flight photograph. The wrinkled spots on the thermal cover are areas where Velcro attachment pads are bonded to the back of the cover. The scalloped effect around the cover edges occurs between the attachment pads. The ground strap is in place with no visible damage, but it appears darker.

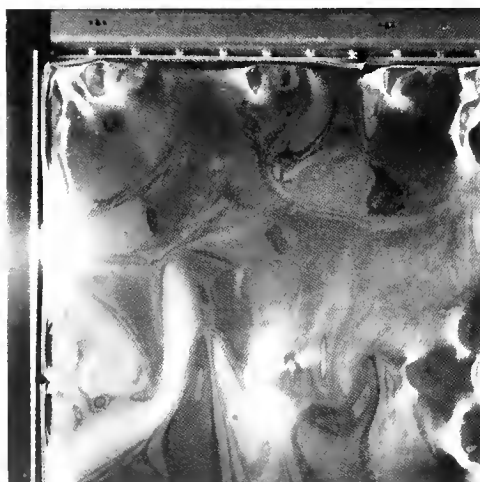
Figure 486 (Postflight). This photograph is of the upper left one-sixth of the tray. The thermal cover appears specular with no apparent damage. There seemed to be no opaqueness on the third of the tray. The reflective properties of the uneven surface of the cover result in various light and color patterns. A very few impact or penetration discolorations are visible. The Velcro attachment pads are evident.

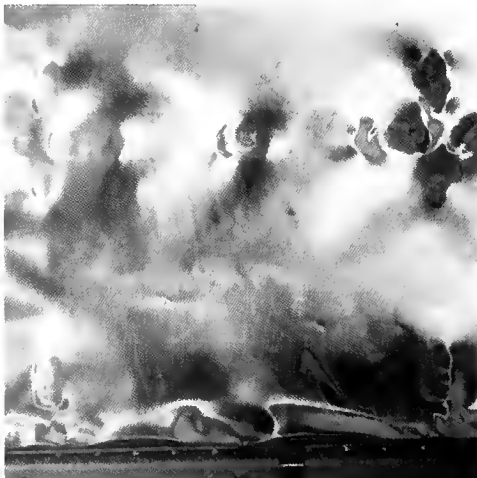
Figure 490 (Postflight). This photograph is of the lower center one-sixth of the tray. The thermal cover has no apparent damage; however an area of some opaqueness is beginning to appear. The reflective properties of the uneven surface of the cover result in various light and color patterns. A very few impact or penetration discolorations are visible. The Velcro attachment pads are evident.

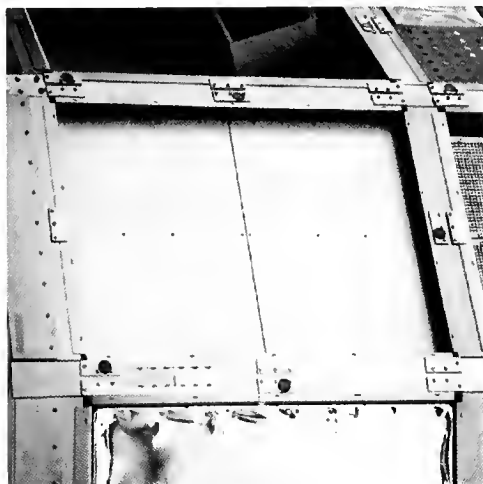
Figure 493 (In Flight). The greenish-gray and pink tints on the two debris panels are by-products of the chromic anodize coating process and are not attributed to contamination or exposure to the space environment. Fingerprints along the center edges of the debris panels indicate improper preflight handling and cleaning.

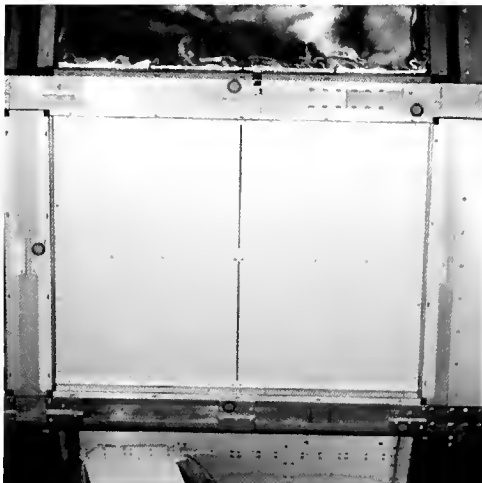
Figure 494 (Postflight). The greenish-gray and pink tints on the two debris panels are by-products of the chromic anodize coating process and are not attributed to contamination or exposure to the space environment. The fingerprints along the center edges of the debris panels that were observed in the in-flight photograph are still visible. The light band across the bottom of the panels is caused by light reflecting from the tray sidewalls.

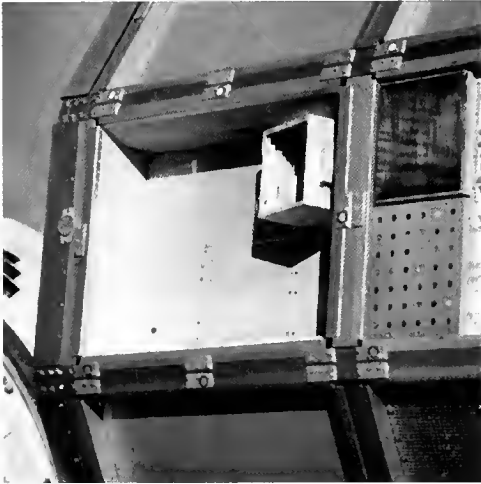
Figure 496 (In Flight). Note the transition in color of tray clamp dots from white to brown, which indicates the transition from leading to trailing side. A handprint, not visible in the pre-flight photograph, is visible on the baseplate in the lower half of the experiment tray. The white dot near the lower corner of the end sidewall is a reflection of the test connector for the ground support equipment, which is located in the lower left corner of the baseplate. The two white dots on the experiment baseplate, near the left end of the tray, appear to be imperfections in the photograph because they were not observed during postflight inspection. The lighting and camera angle provide a clear view of the baffles located inside near the upper edges of the canister housing. The baffles seem to be relatively free of the brown contamination.

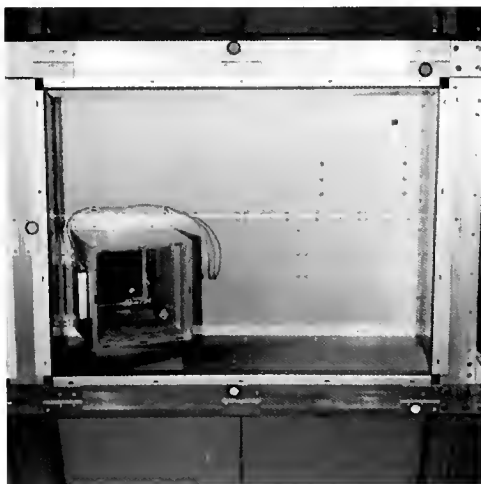
Figure 497 (Postflight). The brown stains are uniform and prominent. The beryllium copper collector foil is clearly visible in this photograph, as are the baffles near the top of the canister housing. However, the fine wire mesh grid cannot be seen. Because of an experiment system malfunction, the canister collector foil that is visible was exposed for the total mission.

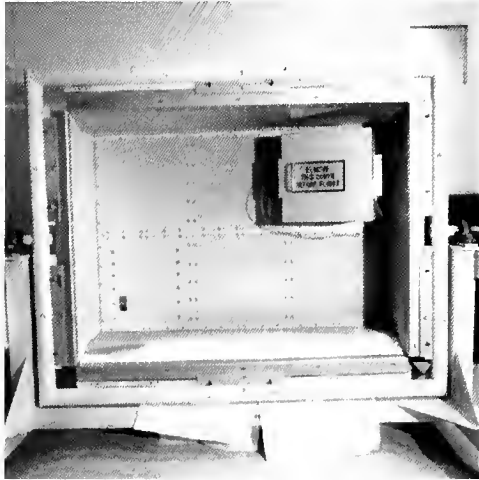
Figure 498 (Postflight). This photograph is of the tray with one of the photographic lights turned off. The brown discoloration is uniform over the tray bottom; however, there is a heavier concentration on the lower left tray wall.

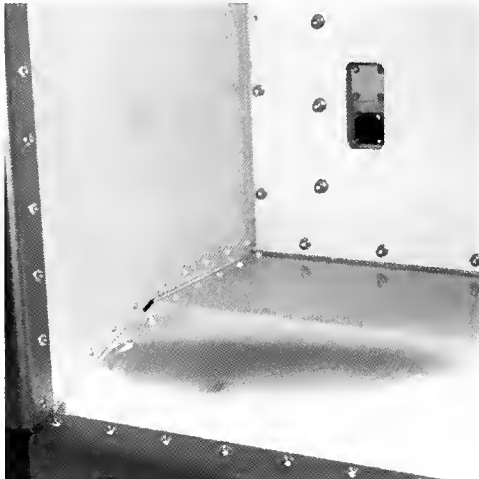
Figure 499 (Postflight). This close-up photograph is of the lower left corner of the tray. There is an area of concentrated brown discoloration on the lower tray wall.

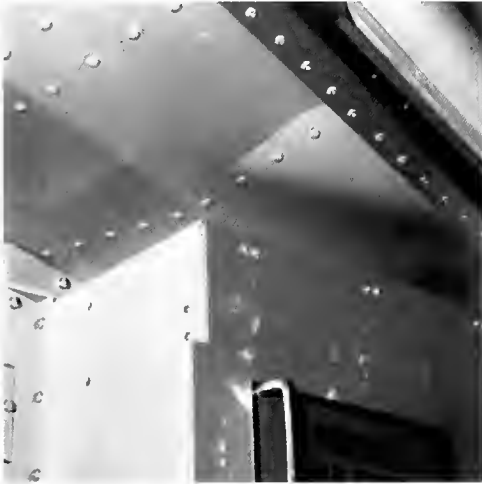
Figure 500 (Postflight). This close-up photograph is of the upper right side of the canister box. The brown discoloration appears uniform, except there is a well-defined discoloration pattern of the canister on the upper tray wall. The cover was installed on the canister housing to protect the space-exposed hardware.

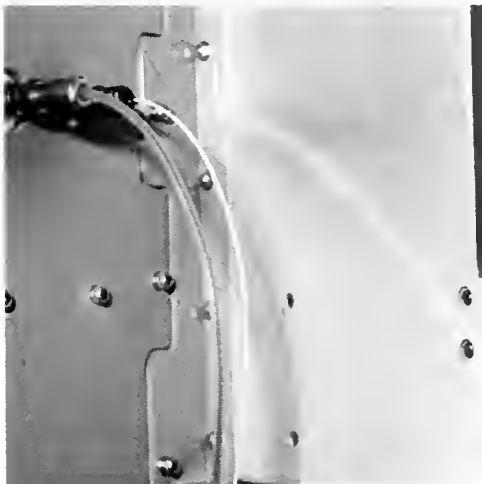
Figure 501 (Postflight). This close-up photograph is of the grid voltage plug area of the tray bottom and left side of the canister box. Note the distinct discoloration pattern of the electrical leads on the canister wall.

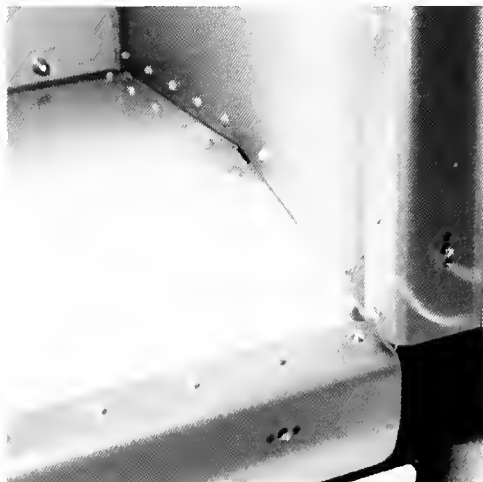
Figure 502 (Postflight). This close-up photograph is of the lower right corner of the tray and shows the contrast in discoloration of the side walls.

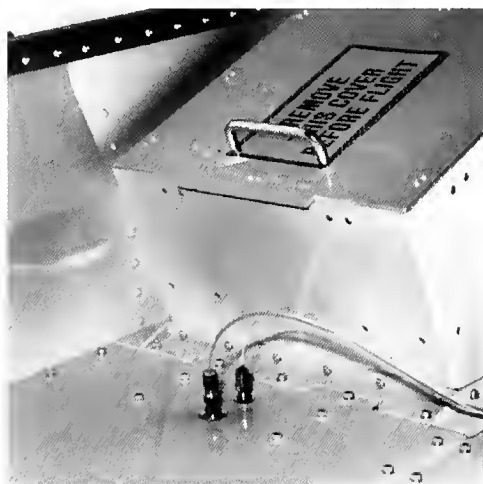
Figure 503 (Postflight). This close-up photograph shows the discoloration pattern of the canister on the tray wall. Also note the faint discoloration pattern of the electrical lead on the canister wall and a shadow resulting from the photographic light below. The cover was installed on the canister housing to protect the space-exposed hardware.

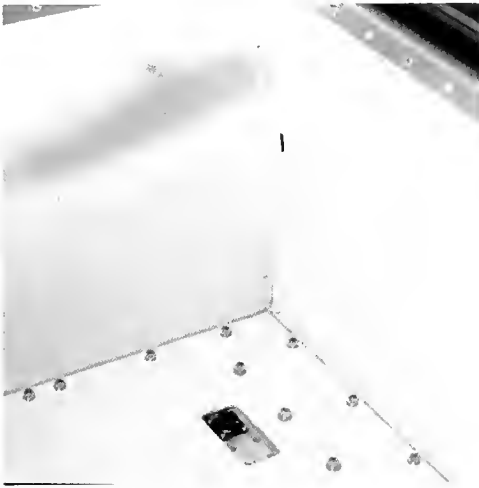
Figure 504 (Postflight). This close-up photograph of the lower left corner of the tray shows the contrast in amount of discoloration.

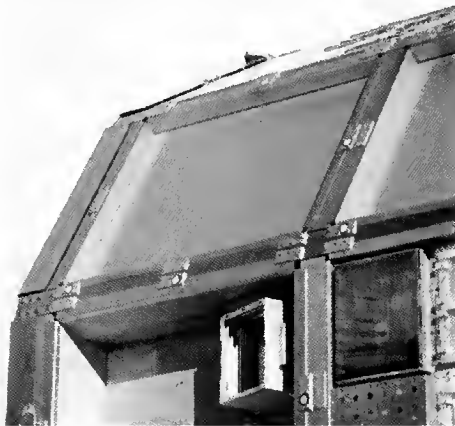
Figure 505 (In Flight). Note the transition of the tray clamp dot color. The discolorations on the upper tray sidewall appear to be fingerprints from handling during the experiment assembly. A portion of the pink and greenish-gray tint on the two debris panels is a by-product of the chromic anodize coating process; however, a part of the intensity can be attributed to reflections of the blue sky. The horizontal streaks on the right debris panel and the vertical streaks on the left debris panel are by-products of chromic anodizing that have been enhanced by the blue reflection. The light band along the vertical edge of the debris panel is a reflection from the tray sidewall.

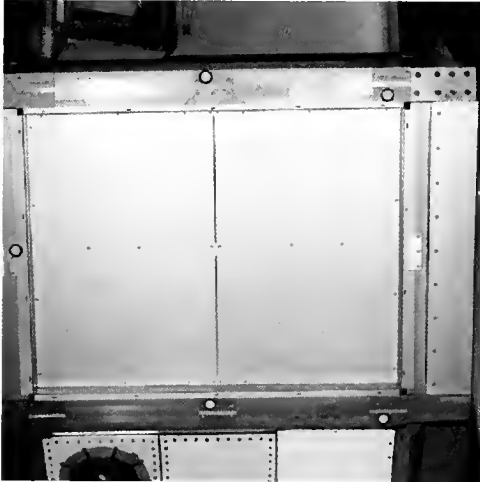
Figure 506 (Postflight). The pink and greenish-gray tints on the two debris panels are by-products of the chromic anodize coating process and are not attributed to contamination or exposure to the space environment. The streaks on the debris panels in the in-flight photographs are almost invisible because the reflection of the sky is not present. The light band along the sides and across the bottom of the panels is caused by light reflecting from the tray sidewalls.

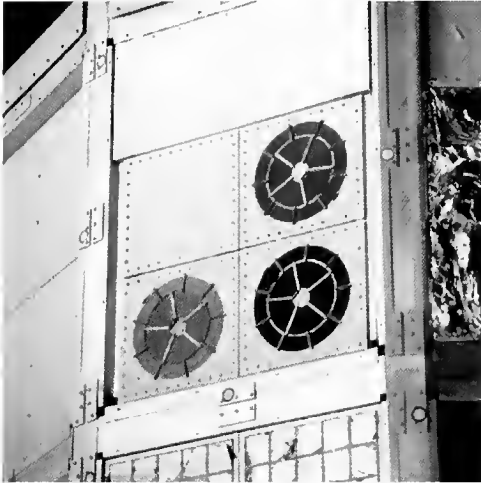
Figure 508 (In Flight). The coils have changed color. The upper right coil, originally glossy black, now appears to be dark brown. The lower right coil, originally a glossy royal blue, now appears to be navy blue. The two 20-m coils of linked fiber optic cables in the lower left have more extensive color changes. The exterior cable that was originally yellow now appears to be slate gray and the interior cable that was light tan appears to be brown.

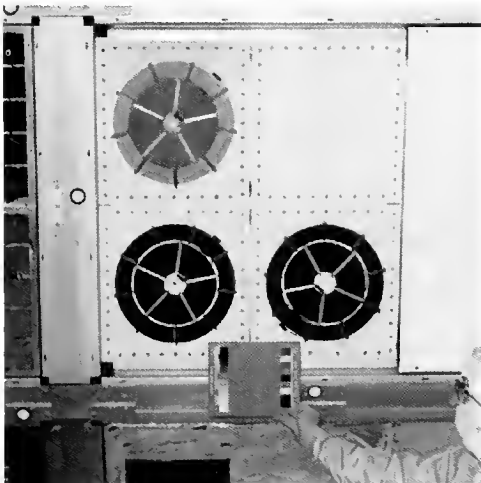
Figure 509 (Postflight). Colors of all three exposed coils of fiber optic cables have changed significantly. The lower right cable, which was originally glossy black, is now dark brown. The lower left cable, which was originally glossy royal blue, is now navy blue. The upper left cable, which was originally yellow and that was slate gray in flight, is now light gray. The cable that was brown in flight is now a lighter brown. The Chemglaze white paint on the large cover plate has maintained the prelaunch color, but the IITRI S13G-LO white paint on the small cover plate has changed to a uniform light tan.

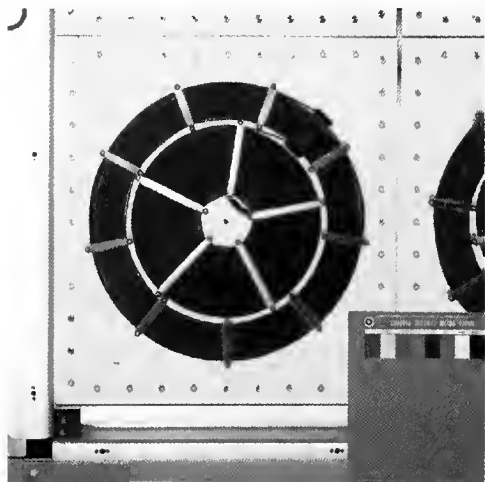
Figure 510 (Postflight). This photograph is of the lower left coil of fiber optic cable. The cable was originally a glossy royal blue, but it is now a darker, duller navy blue. The color of the silicone-rubber spacers under the coil attachment clips has changed from clear to brown. The spacers appear to have discolored the cables. Brown discolorations have appeared at the lower left corner of the tray.

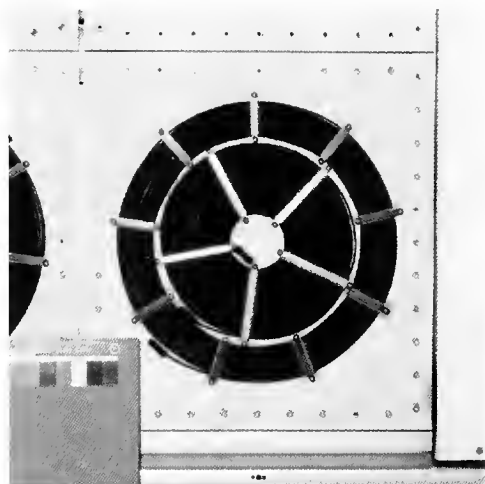
Figure 511 (Postflight). This photograph is of the lower right coil of fiber optic cable. The cable that was originally glossy black is now dark brown. The color of the silicone-rubber spacers under the coil attachment clips has changed from clear to brown. The spacers have discolored the cables. There is some discoloration near the lower right corner of the coil mounting plate

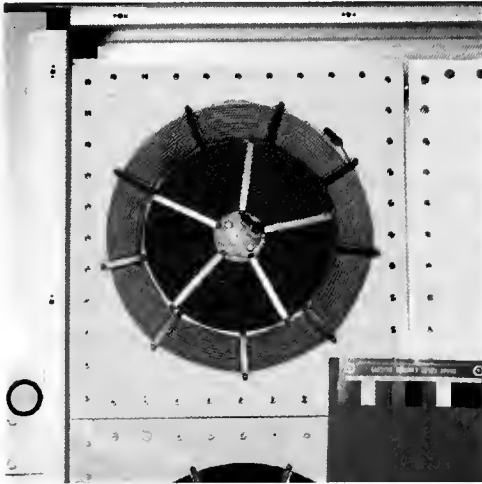
Figure 512 (Postflight). This photograph is of the two 20-m coils of fiber optic cables in the upper left part of the tray. These coils have more extensive color changes than the other coils. The cable that was originally yellow and that was slate gray in the in-flight photograph, is now a light gray. The cable that was brown in the in-flight photograph, now is a lighter brown. The color of the silicone-rubber spacers under the coil attachment clips has changed from clear to brown. The spacers appear to have discolored the cables. There is also discoloration on the mounting plate just above the coils and on the tray at the upper left corner.

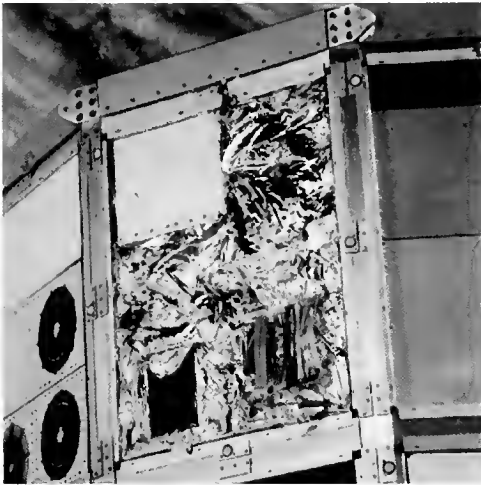
Figure 514 (In Flight). Aluminum particles from the degraded thermal blanket of experiment AO076 are visible on the upper structure intercostal. There is a line of dark discoloration on this intercostal that was adjacent to the edge of the space end thermal panel. An area underneath the edge of the thermal panel allowed venting of the LDEF interior. The external materials of experiment AO076 have changed significantly. The Kapton film on the thermal blanket appears to be completely eroded, except under the buttons that were used to secure the blanket. The erosion left only a very thin coating of vapor-deposited aluminum as a cover. Aluminum coating residue has covered a portion of the black chrome solar collector and also areas of the upper and lower flanges of the trays. The shadow on the tray lower flange indicates that the aluminum extends several inches beyond the tray. One of two thin-film atomic oxygen experiment patches is gone and the other does not appear to be securely attached. The layer of Kapton tape over the thin-film strips appears to be eroded with only the adhesive remaining. The remaining atomic oxygen experiment materials have changed color and most appear to be severely degraded. The silvered Teflon coating of the radiator panel appears diffuse with a light brown discoloration over most of the surface. The black spots on the radiator panel appear to be impact craters where debris penetrated the Teflon material and exposed the silver beneath to atomic oxygen flux. Particles of the degraded thermal blanket material appear to be adhered to the surface of the radiator panel.

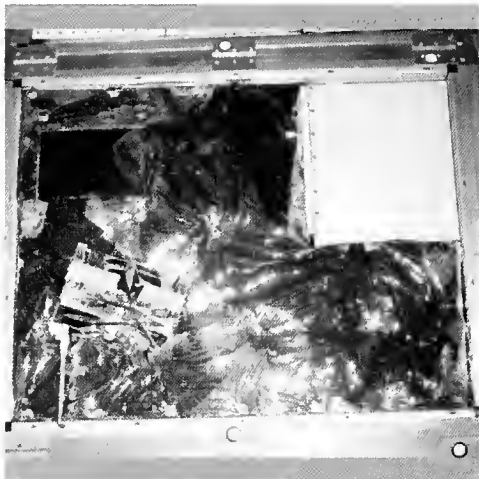
Figure 515 (Postflight). The LDEF structure with the intercostal on the right has a dark brown discoloration that is adjacent to the edge of the space end thermal panel. An area underneath the edge of the thermal panel allows venting of the LDEF interior. Aluminum pieces of the degraded experiment AO076 thermal cover that were lodged in the vent in the in-flight photograph are gone. The external surface of the experiment AO076 has changed dramatically from that observed in the in-flight photograph. The thin coating of vapor-deposited aluminum, which was left after the Kapton film eroded, is essentially gone; only fragments of the coating are left near the edges of the thermal blanket. Pieces of Dacron mesh (bridal veil) material, which was used to separate the thermal cover from the thermal blanket and between sheets of aluminized Kapton film in the thermal blanket, are visible along the edges of the blanket and near the buttons that were used to secure the blanket. A large fragment of the Dacron mesh is folded over the left side of the radiator panel. The large discoloration on the right side of the black chrome solar collector panel is approximately the same shape as the aluminum coating that covered the area in the in-flight photograph. The orientation of the remaining thin-film atomic oxygen experiment patch indicates that the patch is attached to the Dacron mesh and that the attachment is very fragile. The layer of Kapton tape that covered the ends of the thin-film strips appears to have eroded, thus exposing the adhesive. The remaining materials of the atomic oxygen experiment have changed color; most are severely degraded. The silvered Teflon coating of the radiator panel appears diffuse with a light brown discoloration over most of the surface. The white, evenly spaced, discolorations along the horizontal centerline and along the edges of the panel appear to be above countersunk flat head screws used to assemble the experiment. The black spots on the radiator panel appear to be impact craters that penetrated the Teflon material and exposed the silver beneath to atomic oxygen flux. Particles of the degraded thermal blanket material, which appeared to adhere to the surface of the radiator panel in the in-flight photograph, are gone.

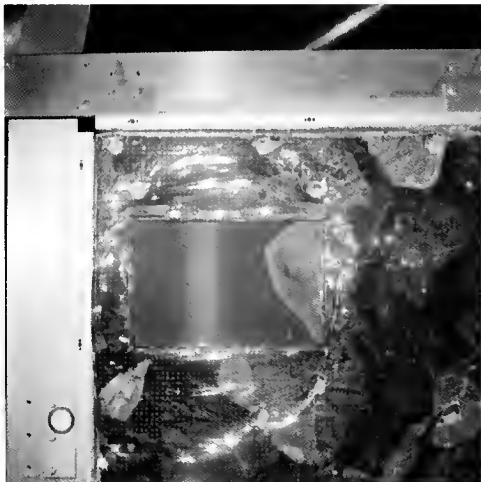
Figure 517 (Postflight). This photograph is of the upper left one-sixth of the tray. The thin coating of vapor-deposited aluminum, left after the Kapton film eroded, is essentially gone and only fragments of the thermal blanket remain. Pieces of Dacron mesh material are visible along the edges of the blanket and near the buttons that were used to secure the blanket. The large area of discoloration on the right side of the black chrome solar collector panel appears to be approximately the same shape as the aluminum coating that covered the area in the in-flight photograph.

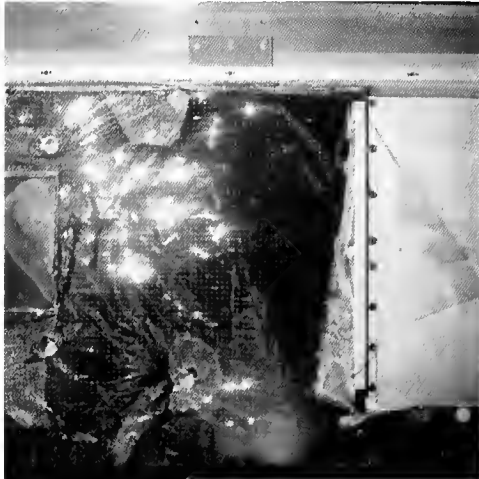
Figure 518 (Postflight). This photograph is of the upper center one-sixth of the tray. The thin coating of vapor-deposited aluminum, left after the Kapton film eroded, is essentially gone and only fragments of the thermal blanket remain. Pieces of Dacron mesh are visible along the edges of the blanket and near the buttons that were used to secure the blanket. A large fragment of the Dacron mesh is folded over the left side of the radiator panel.

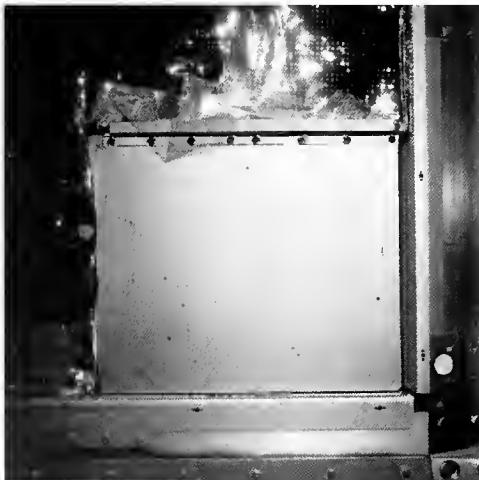
Figure 519 (Postflight). This photograph is of the upper right one-sixth of the tray. The thin coating of vapor-deposited aluminum, left after the Kapton film eroded, is essentially gone and only fragments of the thermal blanket remain. Small discolorations that were caused by impacts are visible on the silvered Teflon film surface of the radiator. Pieces of Dacron mesh are visible. The fragment that covered the left side of the radiator panel has moved to the left.

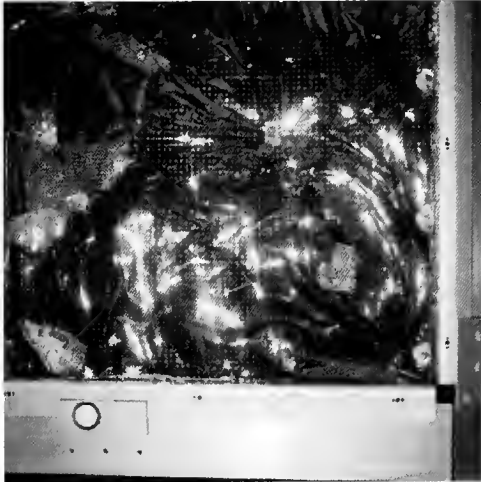
Figure 520 (Postflight). This photograph is of the lower left one-sixth of the tray. The thin coating of vapor-deposited aluminum, left after the Kapton film eroded, is essentially gone and only fragments of the thermal blanket remain. Pieces of Dacron mesh are visible along the edges of the blanket and near the buttons that were used to secure the blanket.

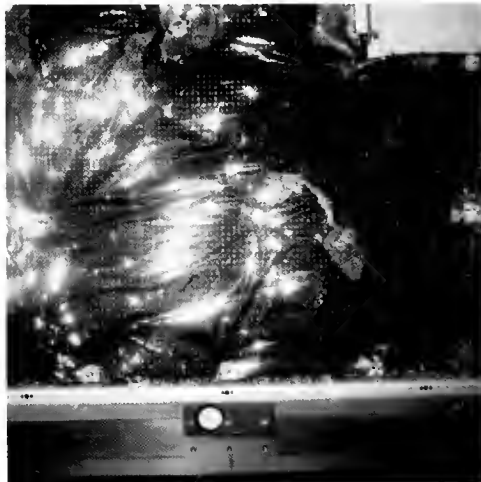
Figure 521 (Postflight). This photograph is of the lower center one-sixth of the tray. The thin coating of vapor-deposited aluminum, left after the Kapton film eroded, is essentially gone and only fragments of the thermal blanket remain. Pieces of Dacron mesh are visible along the edges of the blanket and near the buttons that were used to secure the blanket.

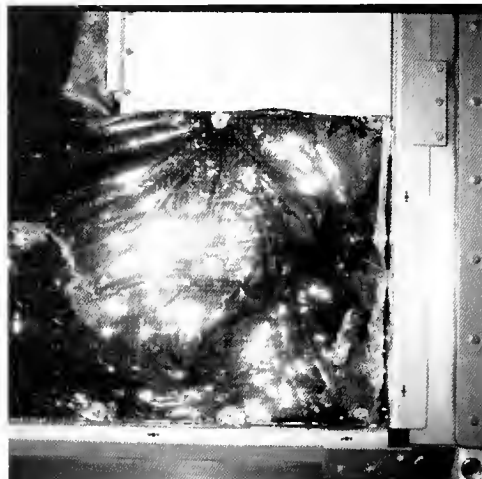
Figure 522 (Postflight). This photograph is of the lower right one-sixth of the tray. The thin coating of vapor-deposited aluminum, which was left after the Kapton film eroded, is essentially gone and only fragments of the thermal blanket remain. Pieces of Dacron mesh are visible along the edges of the blanket and near the buttons that were used to secure the blanket. Note the dark brown discoloration at the edge of the thermal panel at the right.

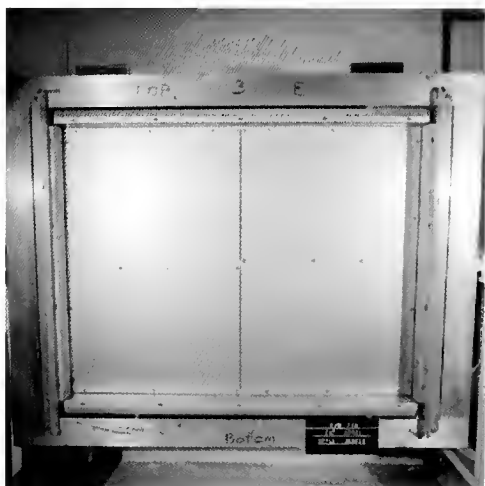
Figure 523 (Postflight). The green tint on the two debris panels is a by-product of the chromic anodize coating process and is not attributed to contamination or exposure to the space environment. A light irregular vertical streak is on the right debris panel. The light band across the top and bottom edges of the panels is caused by light reflecting from the tray sidewalls.

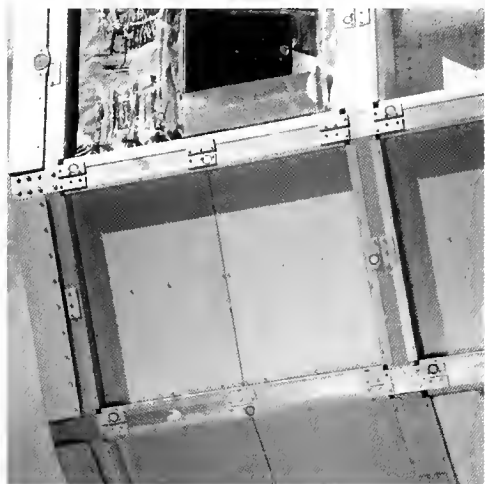
Figure 524 (In Flight). A portion of the greenish-gray tint on the two debris panels is a by-product of the chromic anodize coating process; however, some blue can be attributed to reflection of the sky. The vertical streaks on the right debris panel are by-products of chromic anodizing that have been enhanced by the blue reflection. The brown stains along the top edge of the right debris panel appear to be fingerprints from prelaunch handling.

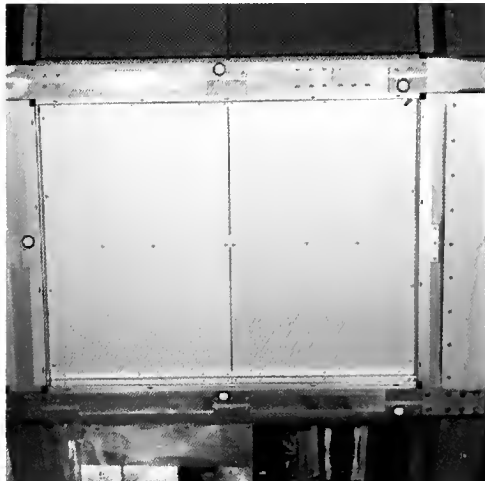
Figure 525 (Postflight). The pink and greenish-gray tints on the two debris panels are by-products of the chromic anodize coating process and are not attributed to contamination or exposure to the space environment. Debris from other experiments that degraded during the mission is visible on the lower experiment tray sidewall at the intersection with the right tray sidewall. A larger piece is located in the upper right corner on the right debris panel. Other experiment debris, which are visible as dark specks, are at the intersection of the debris panel outer edges and the tray sidewalls. The light band along the sides and across the bottom of the panels is caused by light reflecting from the tray sidewalls.

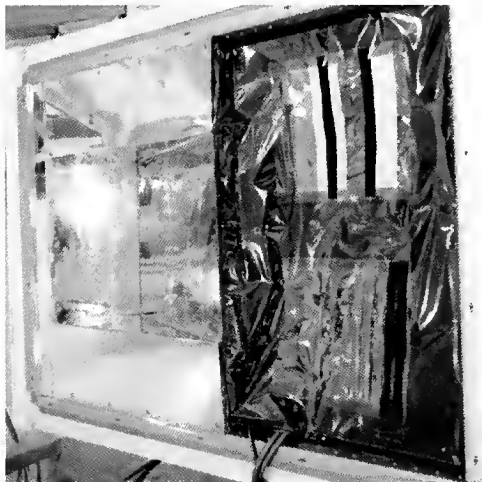
Figure 526 (Preflight). The electrical cables in the lower part of the photograph are non-flight cables that connect the experiment S1001 with the ground support test equipment. The radiator and radiator shield panels located in the left half of the tray were covered with silvered Teflon tape to provide the desired optical properties. The outside of the experiment S1001, except the radiator shield panels and the radiator, was covered with a multilayer insulation blanket that had an outer Kapton film layer coated with vapor-deposited aluminum on one side. Two patches of thin-film materials, part of an atomic oxygen experiment that consisted of 5 patches of 13 samples each, which were located at 3 different places on the LDEF (trays F9, F12, and H1), were attached to the cover of the external thermal blanket with Kapton tape.

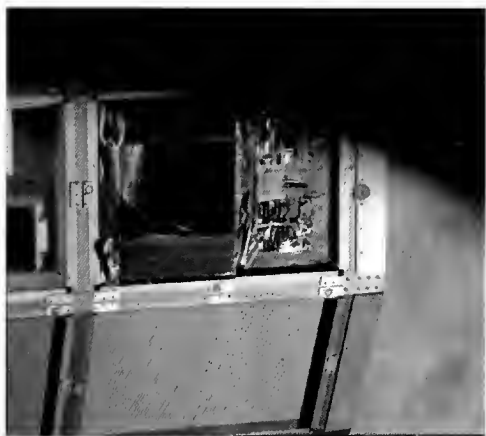
Figure 527 (In Flight). The radiator and the radiator shields appear deep blue, which is apparently caused by the lighting and the reflecting surface. The upper and lower radiator side shields are discolored by a brown stain that is visible through the deep blue. The Teflon tape used to provide continuity between the side shield and end shield appears to be only secured at the outer edges. The tape and the areas initially covered by the tape appear discolored. The external thermal control blanket appears to be in good condition; however, the lower patch of the atomic oxygen experiment materials has many severely degraded samples. Several of the materials have sections that have eroded away and remain attached at only one end. Others are to be completely gone. The materials in the upper patch appear to have survived better, but they are wrinkled and have distorted shapes.

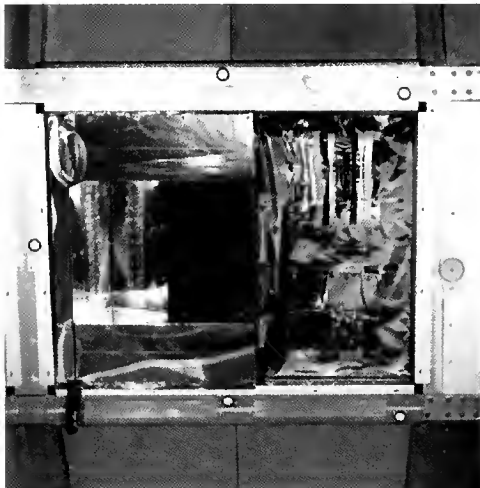
Figure 528 (Postflight). The upper and lower radiator shields have fine vertical marks that may be cracks or abrasions on the surfaces and are discolored by a brown stain. A darker brown stain appears at the intersection of the end shield sections and in the lower left corner where the silvered Teflon tape, which is hanging over the LDEF structure, has pulled away. The area initially covered by the tape appears clean and is outlined by a vertical line of discolored material. The external thermal control blanket has cracks and tears near the intersection with the radiator; it appears more fragile than in the prelaunch photograph. The lower patch of atomic oxygen experiment materials has many severely degraded samples. Several of the materials have sections eroded away and remain attached at only one end. Other materials are completely gone or have only fragments that remain. The materials in the upper patch have survived better, but are eroded, wrinkled, and have distorted shapes. Discolorations that appear to be pieces of Kapton tape lie horizontally across the lower third of the upper patch of materials. Another piece of Kapton tape lies horizontally across the center of the lower patch of material samples.

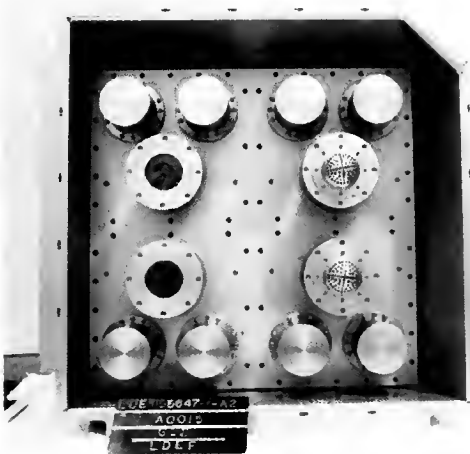
Figure 529 (Preflight). Experiment AO015 consists of 12 hermetically sealed aluminum housings that were coated with Chemglaze II A-276 white paint. The canisters contain the test specimens and are mounted on an anodized aluminum baseplate. Two housings have windows that were covered with Kapton H foil, which provides low-radiation absorption and a light filter. Two others have an anodized aluminum spherical cover with an open area that limits incoming radiation from the albedo of the Earth.

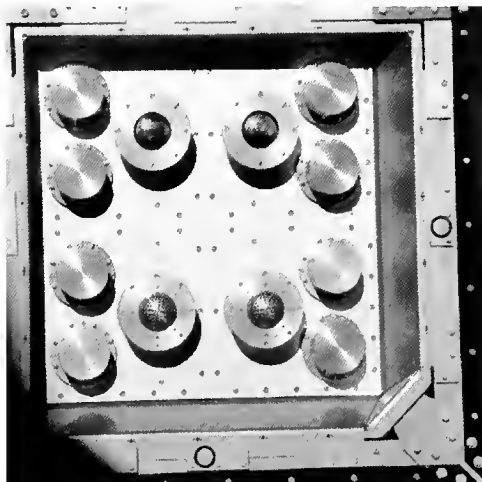
Figure 530 (In Flight). The frame structure is discolored in locations that are adjacent to the edge of the black thermal panels. There is a reflection of canisters in the right and lower tray side walls. The Biostack Experiment AO015 appears to have survived with all hardware in place. The exposed Kapton H foil that covered windows in two detector housings is deformed because of positive internal pressure, but remains intact.

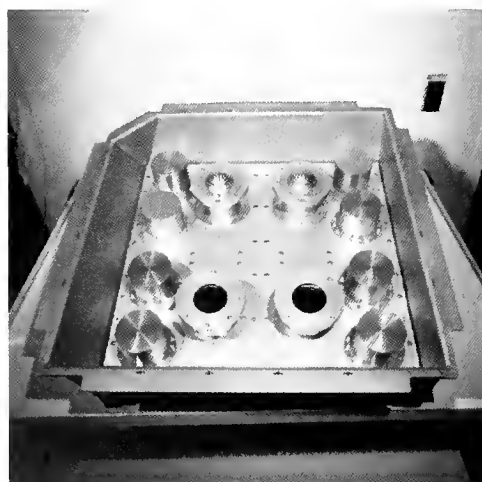
Figure 531 (Postflight). The experiment appears to have survived the extended mission with no visible damage. The experiment housings are intact and all hardware is securely in place. The detector housings appear to have a stain that is similar to that on the tray hardware. The Kapton H foil that covered windows in two detector housings does not appear to have been damaged during the extended mission. The perforated dome on two of the detector housings has a slight tan discoloration, but there is no indication of damage.

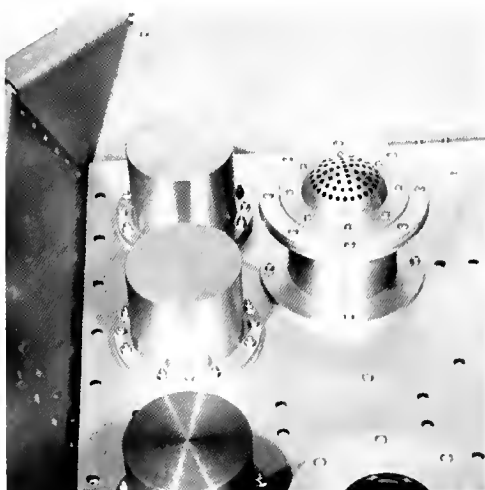
Figure 532 (Postflight). This photograph is of the upper left one-fourth of the tray. The experiment housings are intact and all hardware is securely in place. The detector housings appear to have a light stain.

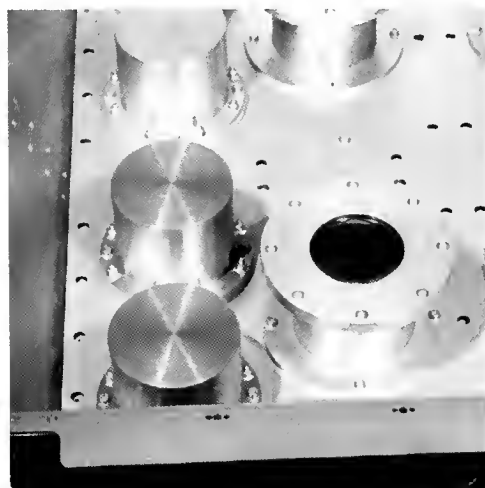
Figure 533 (Postflight). This photograph is of the lower left one-fourth of the tray. The experiment housings are intact and all hardware is securely in place. The detector housings appear to have a light stain.

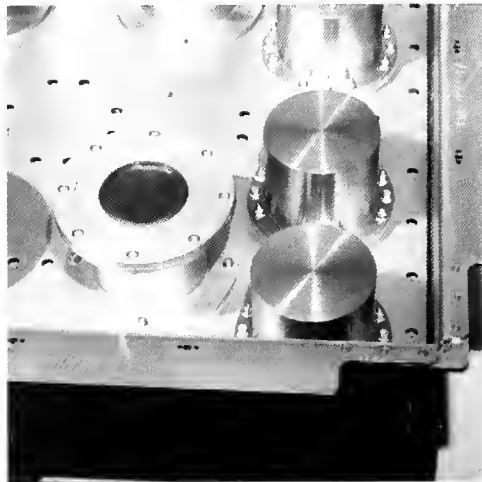
Figure 534 (Postflight). This photograph is of the lower right one-fourth of the tray. The experiment housings are intact and all hardware is securely in place. The detector housings appear to have a light stain.

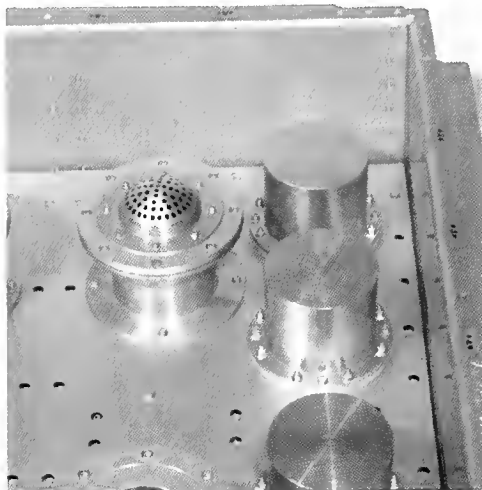
Figure 535 (Postflight). This photograph is of the upper right one-fourth of the tray. The experiment housings are intact and all hardware is securely in place. The detector housings appear to have a light stain.

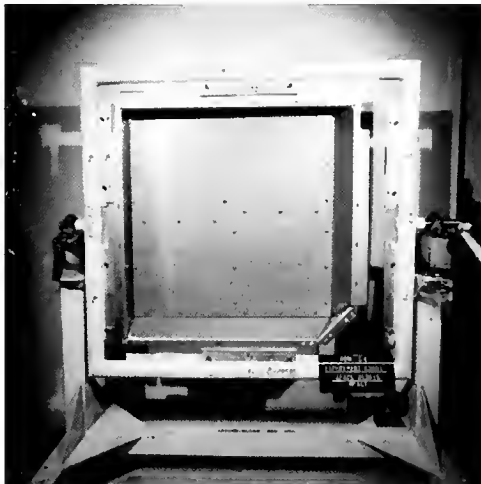
Figure 536 (Postflight). The light pink tint of the debris panel is a by-product of the chromic anodize coating process and is not attributed to contamination or exposure to the space environment. A brown stain is located in the lower right corner of the tray.

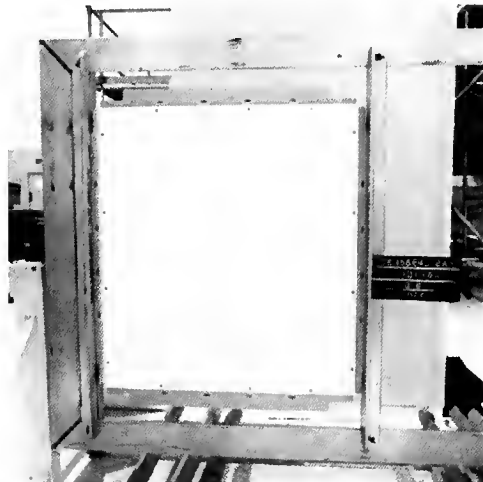
Figure 537 (Preflight). Experiment AO139A consisted of four specially designed reactors that were housed in a thermally controlled aluminum cylinder, heaters, a data recording and control system, and lithium sulfadioxide batteries as the power source. The experiment was thermally isolated from the albedo of the Earth by an aluminum cover plate that was attached to clips, which were installed on the experiment tray sidewalls. The outward facing surface of the cover plate was coated with Chemglaze A276 white paint over Chemglaze 9924 wash primer. The aluminum surface that was facing the tray interior remained uncoated.

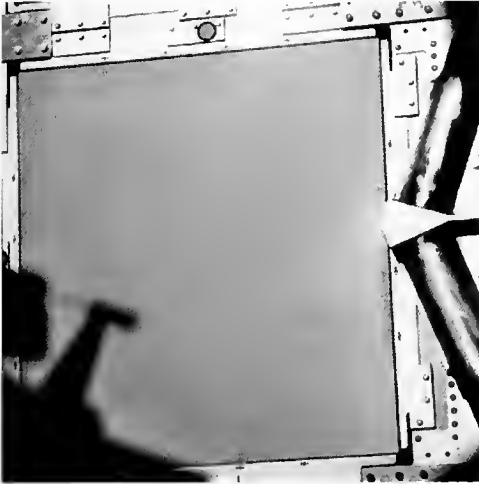
Figure 538 (In Flight). The cover plate appears brown because of the lighting. Later photographs indicated that the cover was a slightly discolored white. The narrow band of discolorations at the right, left, and upper edges of the cover plate appears to be areas of masking tape residue that have turned brown.

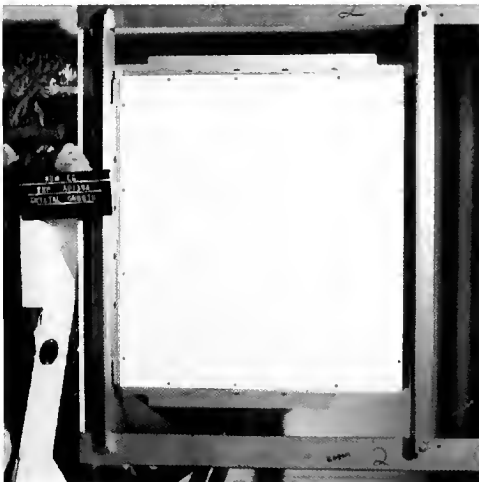
Figure 539 (Postflight). Experiment (AO139A) appears to have survived the extended mission with no visible damage. Some discoloration appears near the center of the left flange of the tray. The experiment cover plate, which was originally white, is discolored by a very light brown stain, but it is intact and securely in place.

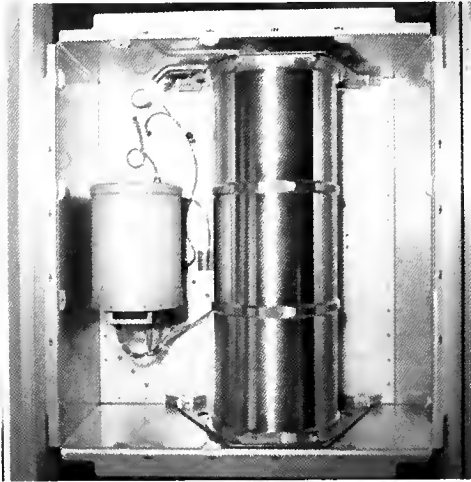
Figure 540 (Postflight). This photograph is of the tray after the thermal cover has been removed. The four specially designed reactors are housed in the thermally controlled aluminum cylinder in the center of the tray.

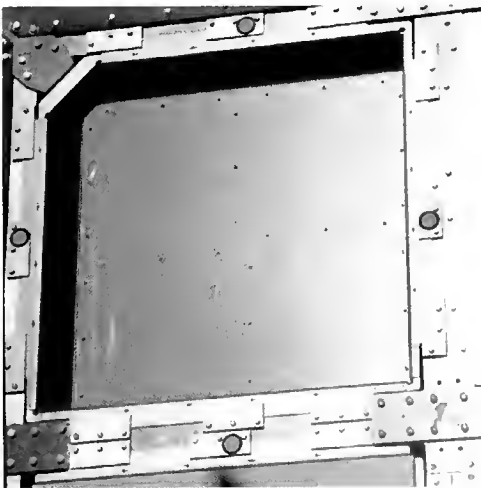
Figure 541 (In Flight). The darkness in the left section of the debris panel is attributed to the lighting, although the panel appears to have a light discoloration. The scrapes and scratch marks are from preflight handling and are not mission related.
